NEWSFLASH

Two recent near misses have come to our attention:

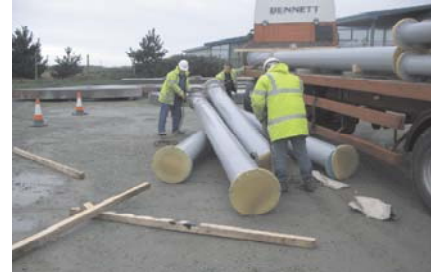
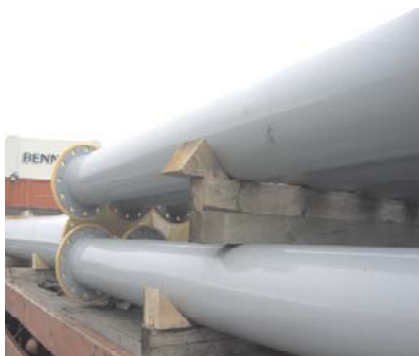
The **first** incident occurred in North Wales, when a consignment of Scotch coated steel pipes was delivered to site from a coating facility near Cardiff. As the driver prepared to off load the pipes by loosening the restraining straps, some of the pipes rolled off the side of the lorry.

Fortunately the pipes fell off on the opposite side to the side the driver was standing; otherwise there would have been serious consequences. On investigating the loading configuration it was discovered that the pipes were supported on plain timber, without any profile to suit the shape of the pipes and simple wedges were used without any means of lateral restraint.

In some places nails were used to prevent the pipes from moving. (See photographs). The suppliers of the pipes and haulier are involved in the investigation process.

All loads must be inspected for stability before the off loading process begins. If necessary the load should be refused and returned to the haulier's depot after being made safe.

Ensure that a suitable Safe System of Work (SSoW) is prepared and adopted on your sites for large one off type loads. In particular a SSoW should identify how personnel will access and be prevented from falling from materials where these are stacked high on the back of an articulated trailer.

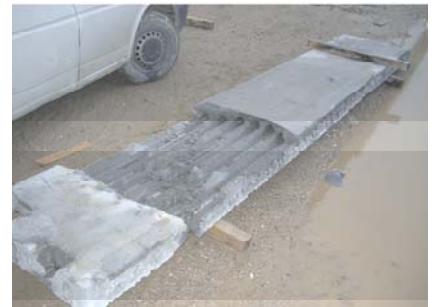
The **second** incident occurred when a 5m x 0.8m wide Bison concrete floor plank delaminated whilst being lifted into position. Fortunately all of the falling pieces were retained in the safety net.

Bison representatives were involved in the subsequent investigation and they concluded that the failure was due to the fact that reinforcing loops, used to lift the plank during manufacture, had been inadvertently left in position and used to lift the plank on site.

Bison's procedures require that these reinforcing loops be cut off prior to planks leaving their factory. If they have been inadvertently left in situ they must not be used as lifting points on site. This is clearly stated on the delivery tickets.
